US Army Corps  
of Engineers  
Fort Worth District

# Embankment Criteria, Performance, and Foundation Report

**Waco Lake  
Bosque River, Texas  
Brazos River and Tributaries, Texas**

January 1990

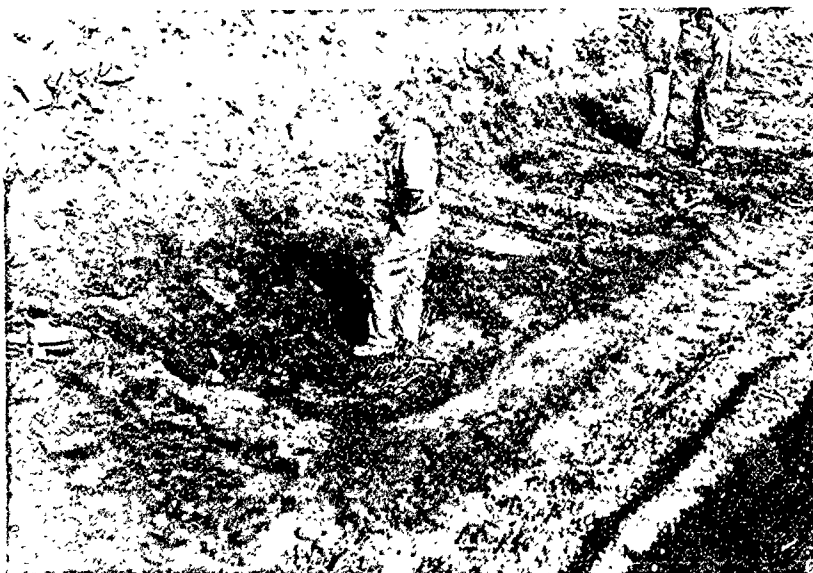
PHOTO 11. Upturned Eagle Ford shale on the down-thrown side of the South Fault in the upstream fault excavation.
